Entergy Nuclear Generation Co.  
Pilgrim Nuclear Power Station  
600 Rocky Hill Road  
Plymouth, MA 02360

The enclosed Licensee Event Report (LER) 2001-006-00, "Automatic Scram During Surveillance Test and Subsequent Reactor Water Level Anomalies," is submitted in accordance with 10 CFR 50.73.

**FACILITY NAME (1)****PILGRIM NUCLEAR POWER STATION****DOCKET NUMBER (2)****05000-293****PAGE(3)****1 of 16****TITLE (4)****Automatic Scram During Surveillance Test and Subsequent Reactor Water Level Anomalies**

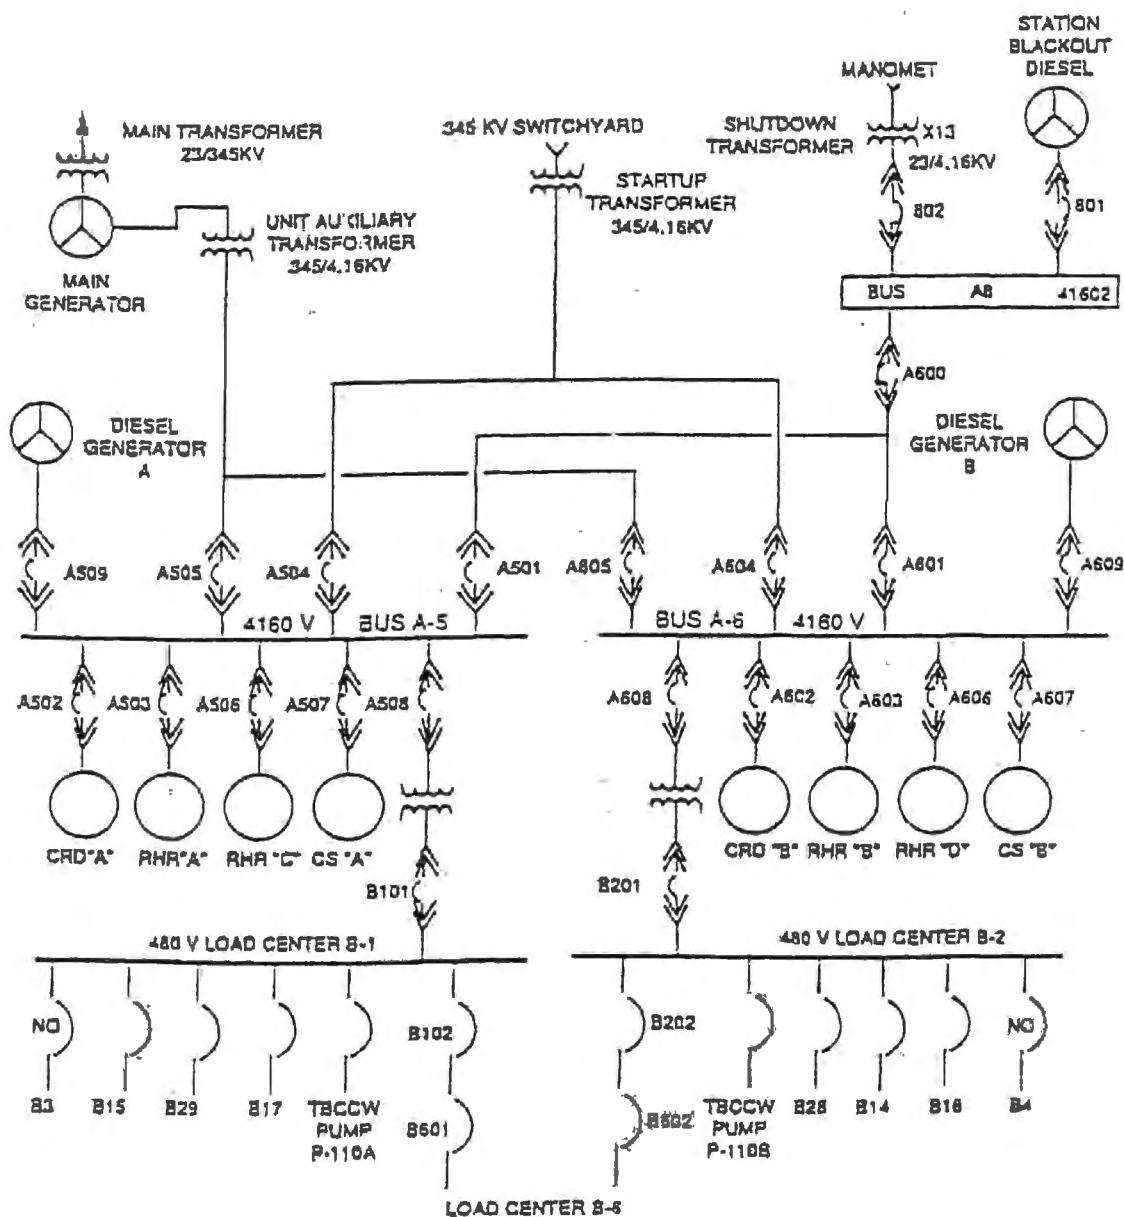
SIMPLIFIED DRAWING of  
PREFERRED and SECONDARY OFFSITE POWER SOURCES  
and  
EMERGENCY SERVICE PORTION of the  
AUXILIARY POWER DISTRIBUTION SYSTEM

On August 13, 2001, at 1108 hours, Emergency Diesel Generator (EDG) "A" was removed from service for a planned surveillance activity. When EDG "A" was removed from service all of the offsite and onsite power sources were available, and all of the 345 kV switchyard breakers were closed. The 4.16 kV auxiliary power distribution system (APDS), including nonsafety-related 4.16 kV Buses (A1, A2, A3, A4) and safety-related 4.16 kV Buses A5 and A6 and related AC electrical system and loads, were powered from the Main Generator via the Main Transformer and Unit Auxiliary Transformer. The control switches for a fast transfer of the 4.16 kV buses were in the ON position. A simplified one-line drawing of the offsite power sources, EDGs, and emergency service portion of the APDS and related electrical system is provided at the end of this report.

- The RPS Channel "A" trip signal was the result of Bus A5 becoming de-energized while the RPS Bus "A"/Channel "A" was powered from Bus A5 via Buses B1, B6, B10, RPS standby transformer X20, EPA-5 and EPA-6. The loss of power resulted in the de-energizing of the coils of RPS Channel "A" relays. The RPS relays are normally energized and are designed to de-energize for the trip function.

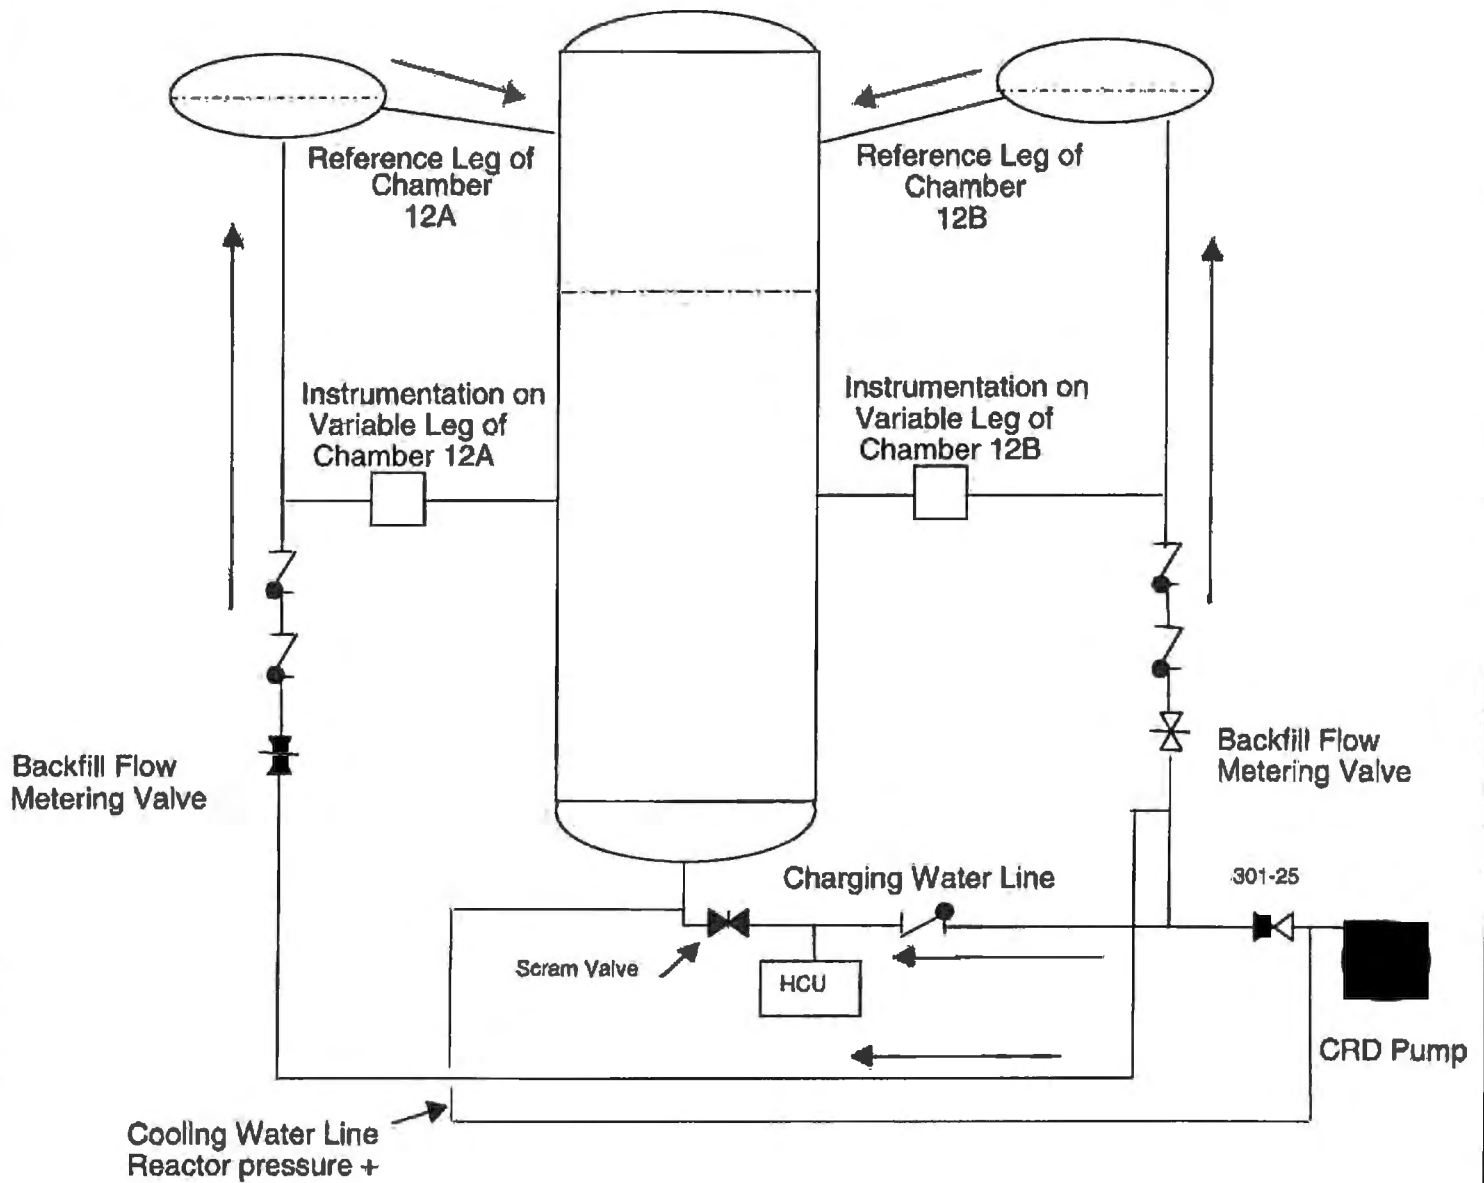
**Simplified Drawing of Reference Leg Backfill System  
(Condensing Chambers 12A & 12B)**

Analysis indicates the water level changes sensed by the related reactor vessel water level instrumentation resulted from the draining of water from the reference legs connected to Condenser Chambers 12A/B. The draining of water was the result of reverse flow past the reference legs' backfill system check valves. The draining reduced the water inventory from the reference legs and caused the instrumentation (level transmitters) to sense a higher than actual reactor water level.

The backfill system for the reference legs connected to Condensing Chambers 12A/B was designed to be backfilled with water from the CRD System charging water piping. The backfill flow was interrupted when the CRD charging water block valve (HO-301-25) was closed to allow all CRDs to settle and achieve a fully inserted position indication on the reactor control panel after the scram. Later, the reset of RPS was performed when the reactor vessel pressure was approximately 725 psig. The 725 psig pressure was greater than the CRD System HCUs' accumulator pressure of approximately 570 psig. The reset of the RPS includes the automatic closing of the CRD scram valves which result in the HCUs' accumulators being available to accept water displaced from the reference legs. The resulting hydraulic conditions of reactor pressure greater than CRD charging water header pressure (downstream of valve HO-301-25), no backfill flow from a CRD pump (valve HO-301-25 closed), and reverse flow through the backfill system check valves, allowed the displacement of water from the reference legs to the HCUs' accumulators.

The displacement occurred past the backfill system check valves and was greater than would be normally experienced because the backfill system flow metering valves were at a maximum flow setting. The check valves did not actuate because the differential pressure across the check valves was not sufficient to cause the check valves to close. The check valves are designed to close at a differential pressure of six psi (psid) or less. After the event, calculations were performed and the check valves were tested. The calculations concluded the check valves experienced a differential pressure of approximately one and one-half psid for this event. The results of the as-found check valve testing determined the valves closed between two and six psid. Therefore, the check valves would not have been expected to close under the conditions experienced for this event.

As an immediate action, the backfill system was isolated from both reactor vessel reference legs connected to Condensing Chambers 12A/B. An engineering evaluation provided the basis for operability of the related reactor vessel instrumentation with the backfill system isolated. Longer term corrective action(s) were being considered when this report was prepared. The focus of the corrective action(s) is to preclude the draining of water from the reference legs connected to Condensing Chambers 12A/B. This action(s) will be tracked in the corrective action program (PR 01.9774).
